SUMMARY OF ANALYSIS

Your Reference: State of Arizona v Rafaela Vasquez; GO# TE 2018-32694
Wolf Project No.: 19-0117-4827

RE: State of Arizona v Rafaela Vasquez
Claim or File No.: GO# TE 2018-32694
Wolf Project No.: 19-0117-4827

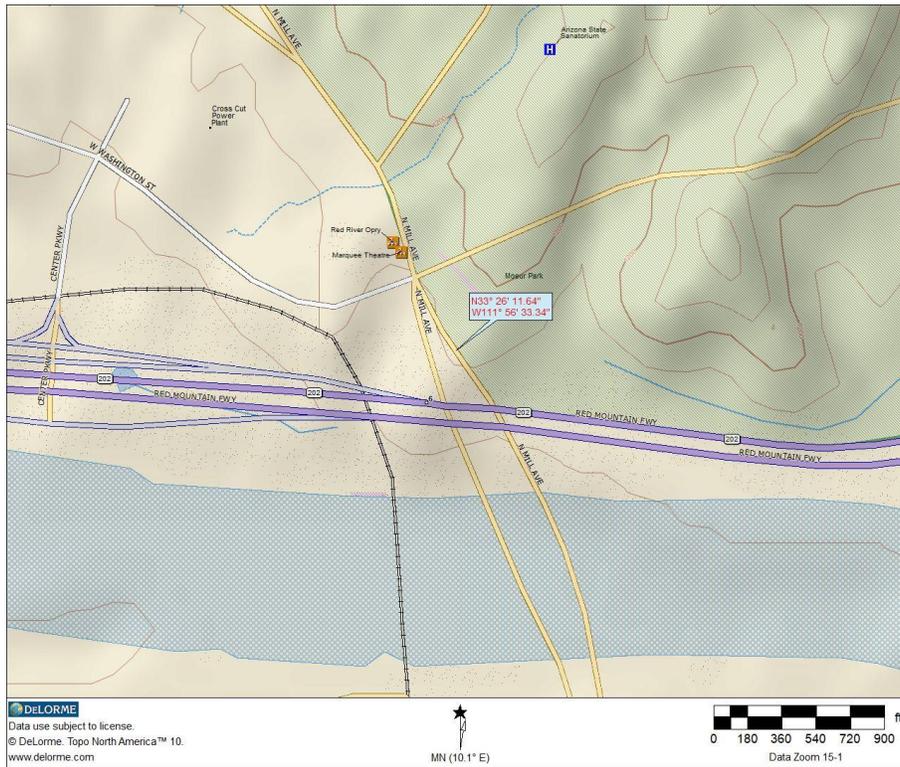
Figure 1 A topographic map showing collision site. The point of impact is indicated by the blue coordinate flag.

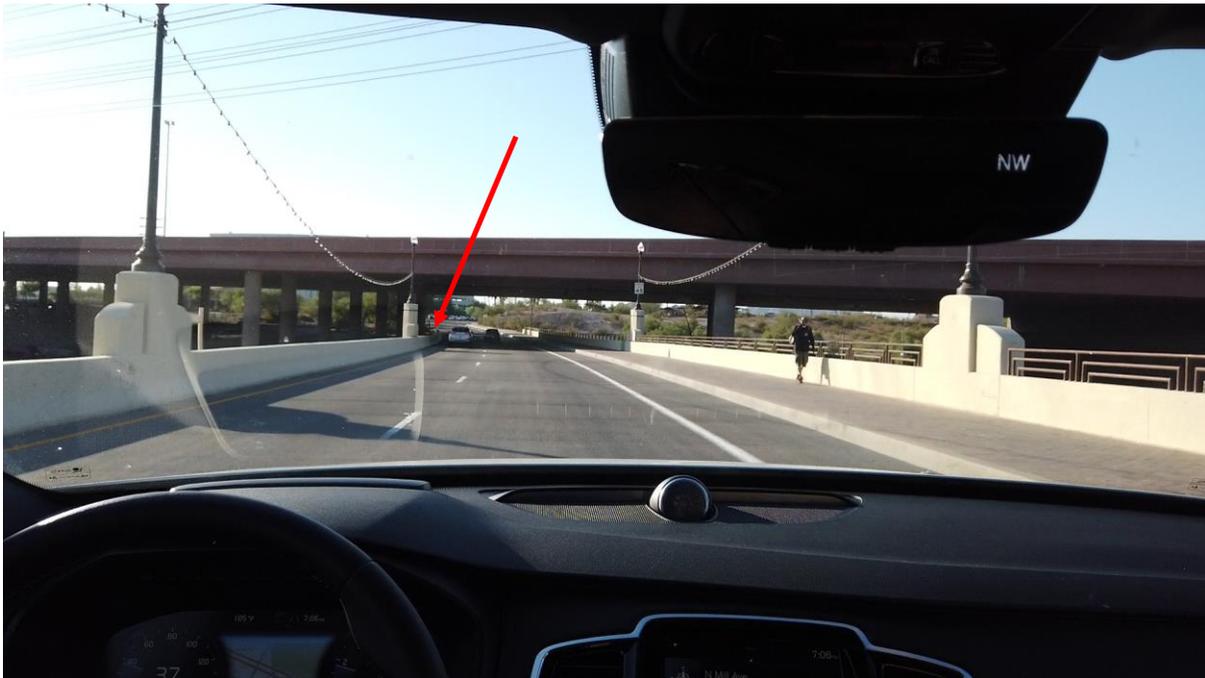
As motorists travel over the bridge toward the collision site, they pass under the bridge which carries Arizona State Road 202³ over North Mill Avenue. The bridge support columns and some trees just north of the bridge combine to limit the sight line to the collision site for northbound drivers on North Mill Avenue until those drivers are a little over 800 feet from the collision point.

Figure 2 Looking north from the northbound bridge across the Tempe Town Lake. This image is about 811 feet from the point of impact. The red arrow points to where Ms. Herzberg would have initially become visible to Ms. Vasquez.

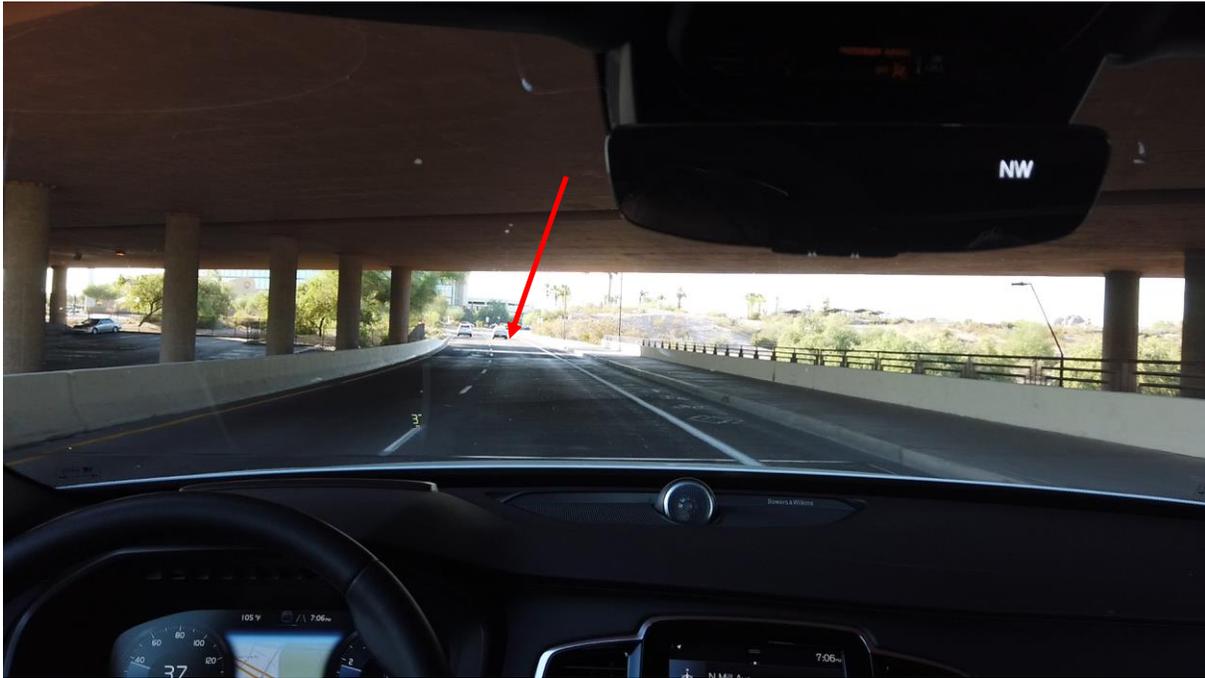
Figure 3 The view from underneath the SR 202 bridge. The car in the right-hand lane is at about the incident point of impact

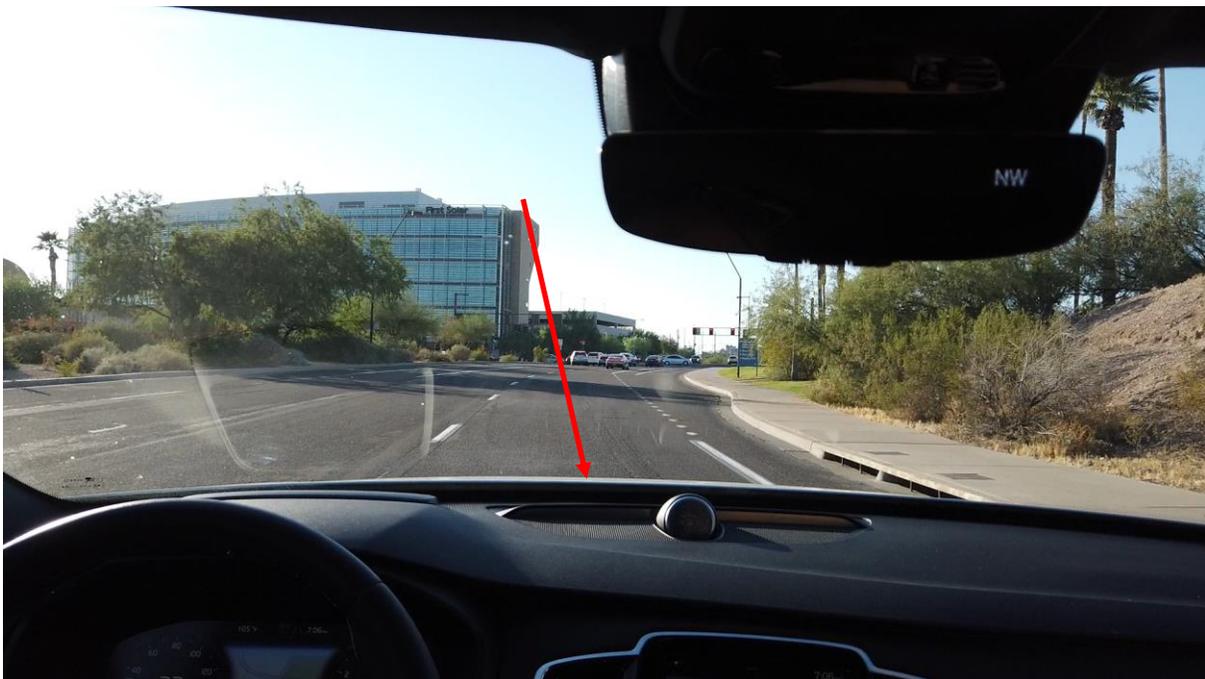
Figure 4 A daytime video image from about 50 feet away from the point of impact. The red arrow marks the bicyclist's feet location on the pavement at the time of impact.

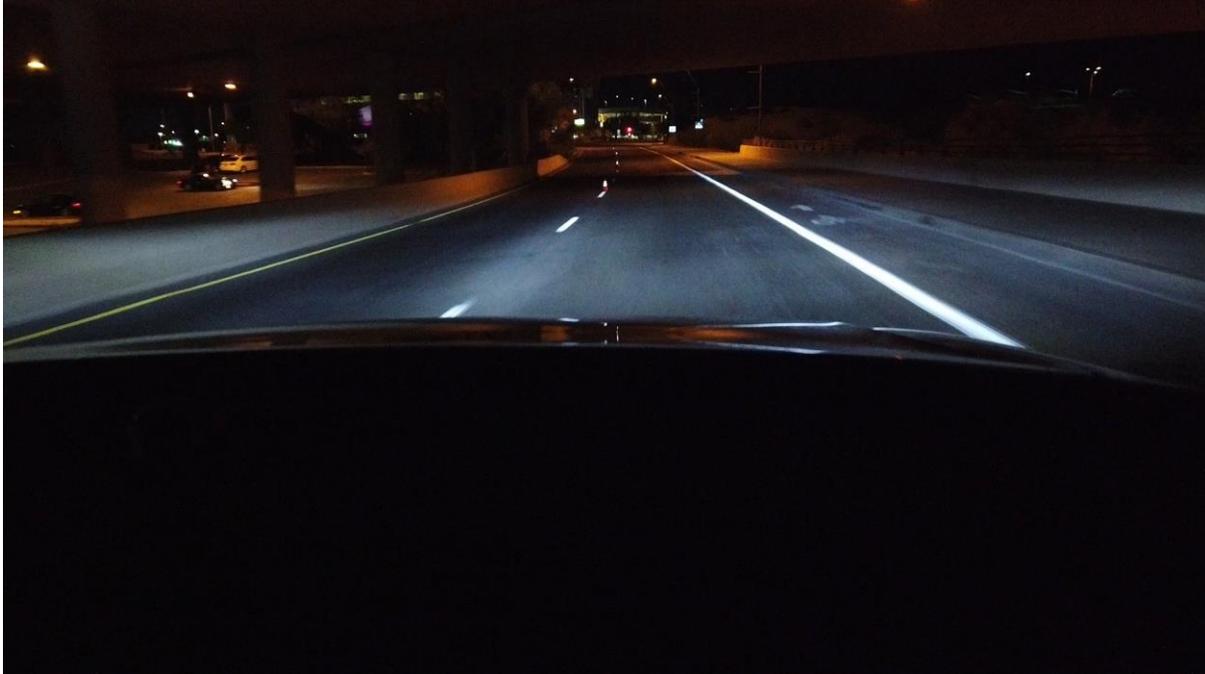
Figure 5 A night video image from the exemplar Volvo XC90 operating on low beam from a distance of 500 feet from the point of impact.

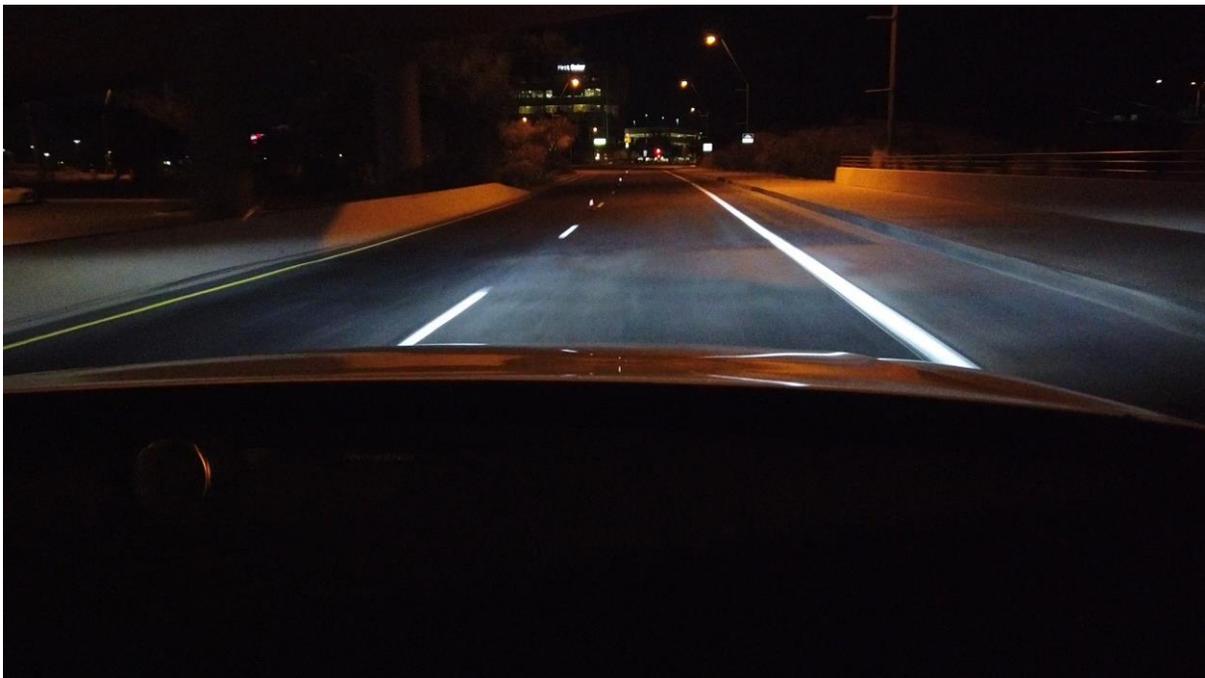
Figure 6 The view from 400 feet from the point of impact.

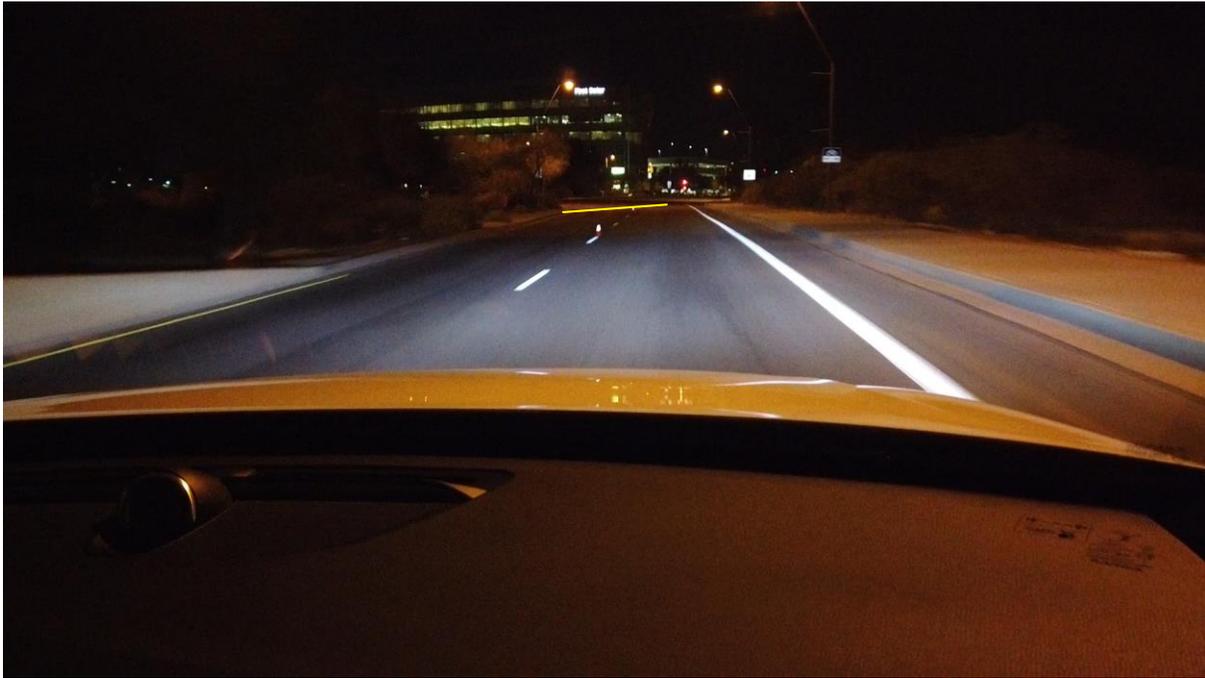
Figure 7 The view from a distance of 300 feet. The yellow line is the approximate track that Ms. Herzberg walked across the road.

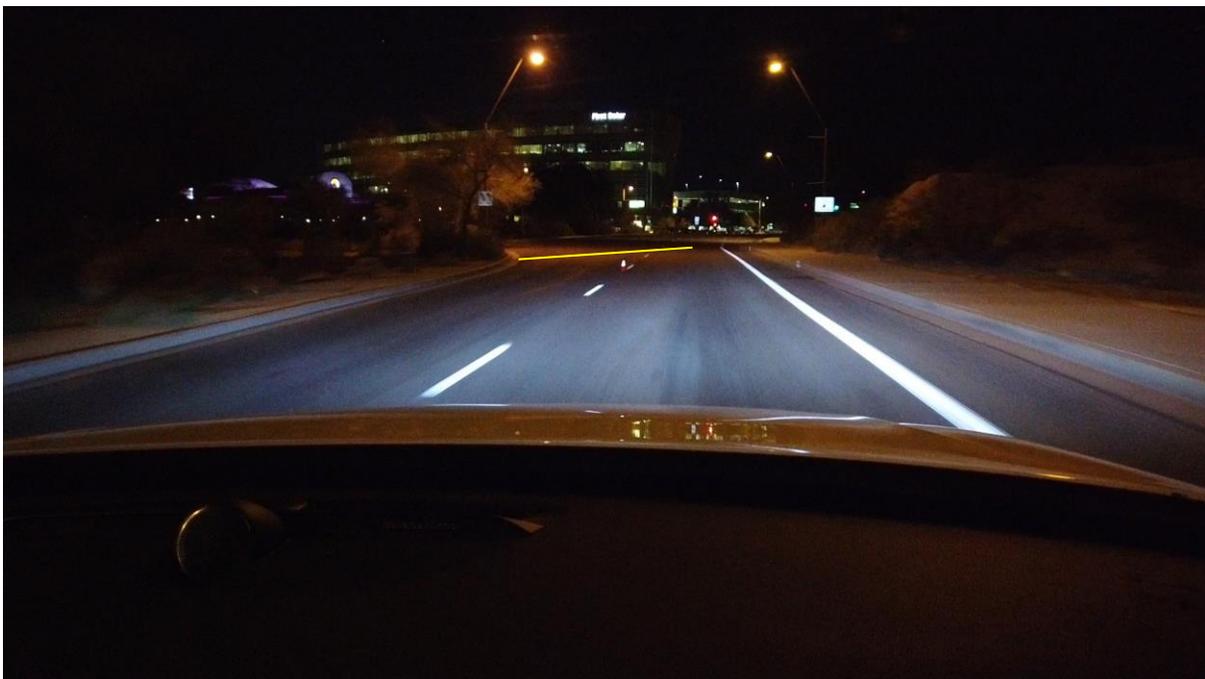
Figure 8 The view from 200 feet. Again, the yellow line marks the track walked by Ms. Herzberg.

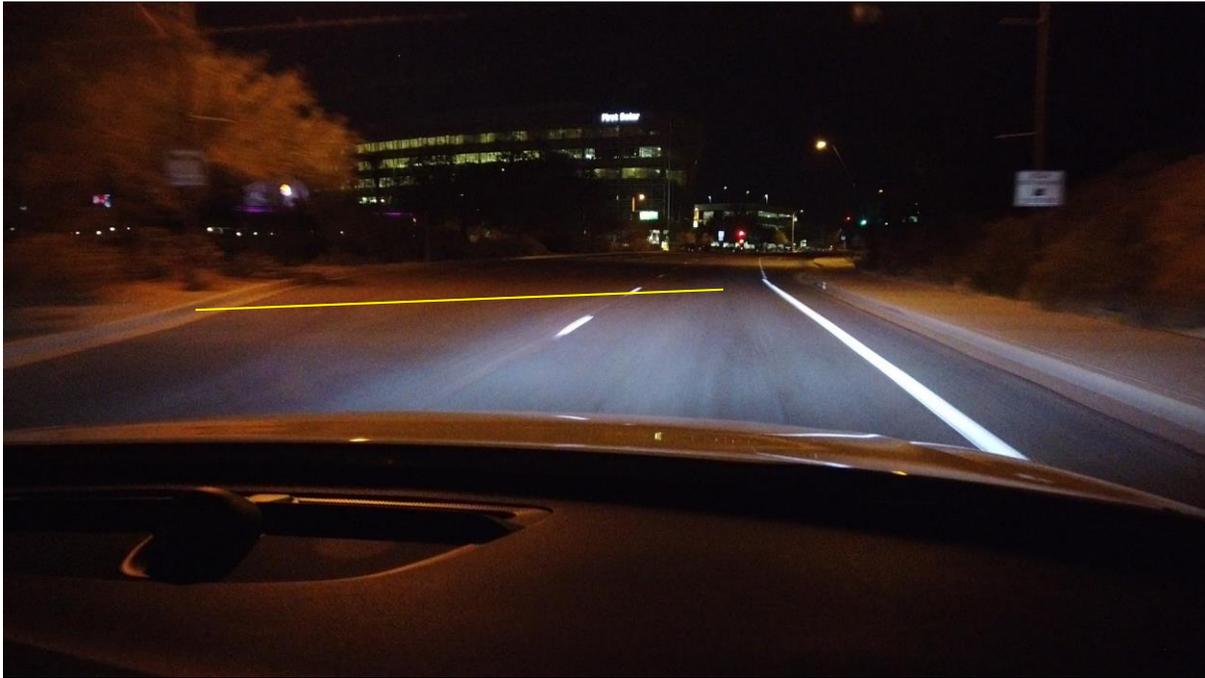
Figure 9 The view from the exemplar Volvo on low beam at 100 feet from the point of impact.

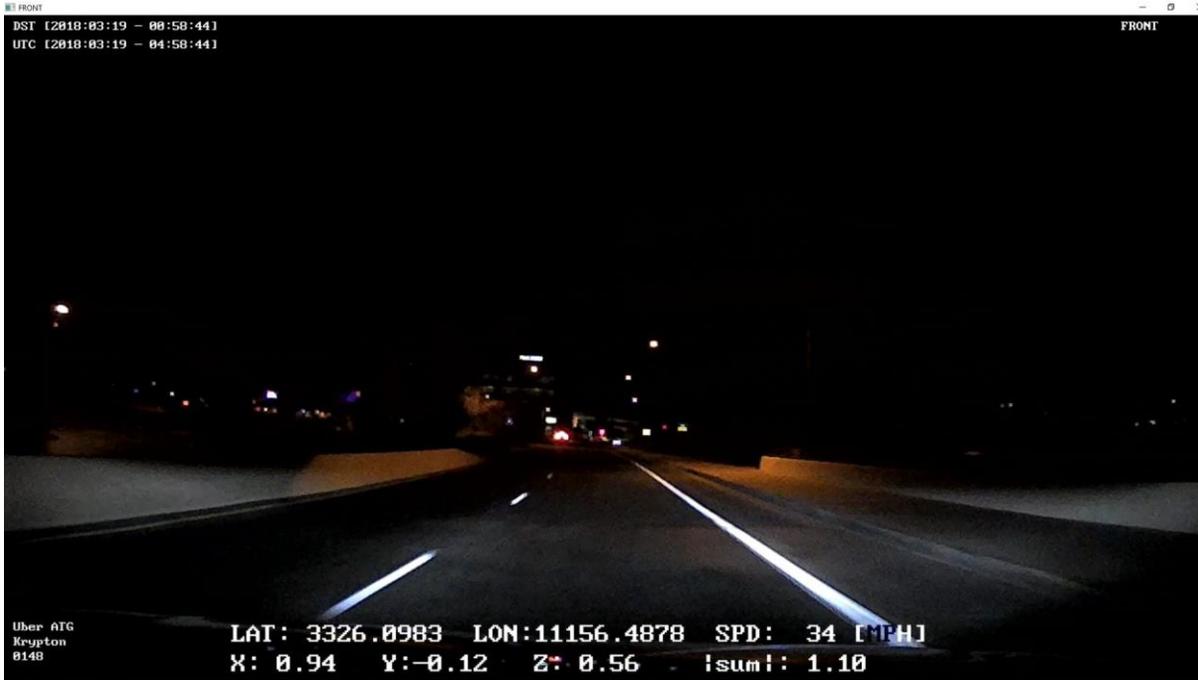
Figure 10 Accident video 500 feet from point of impact.

The video coverage from the front interior camera, however, does not reveal Ms. Herzberg until the more intense portion of the low beam pattern finally reaches Ms. Herzberg's shoes. Even with brightness and contrast enhancement, that video does not reveal any evidence of the pedestrian or the lighted surfaces nearby including the background surfaces against which she was presented. Streetlamp patterns with illuminance values well above 3 foot-candles directly under the lamp heads were not visible in the accident video although they did show in the background of some of the police scene photographs even though those photographs were flash-assisted.

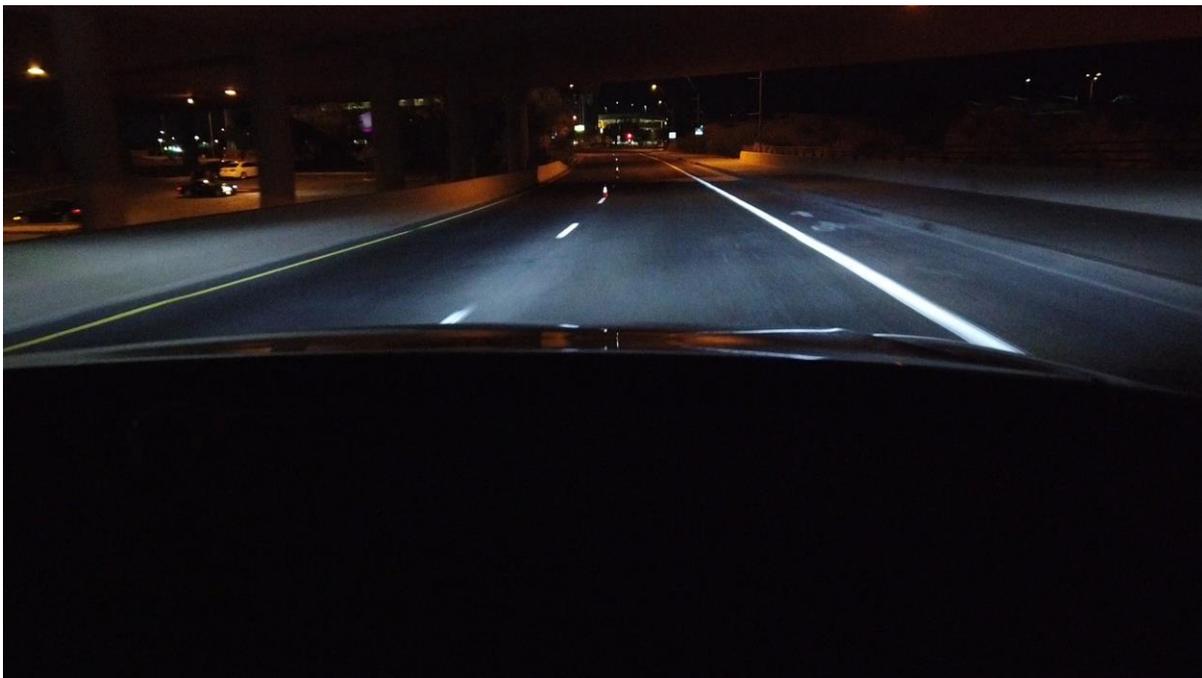
Figure 11 Osmo Pocket 500 feet from point of impact.

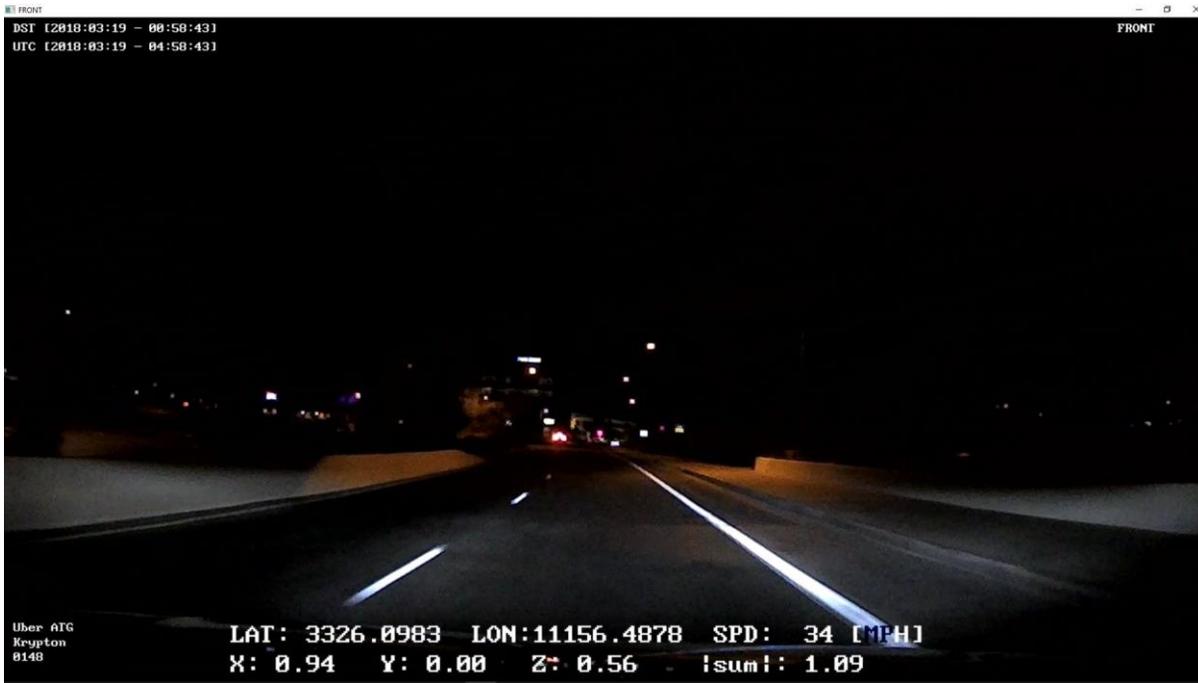
Figure 12 Accident video 400 feet from point of impact.

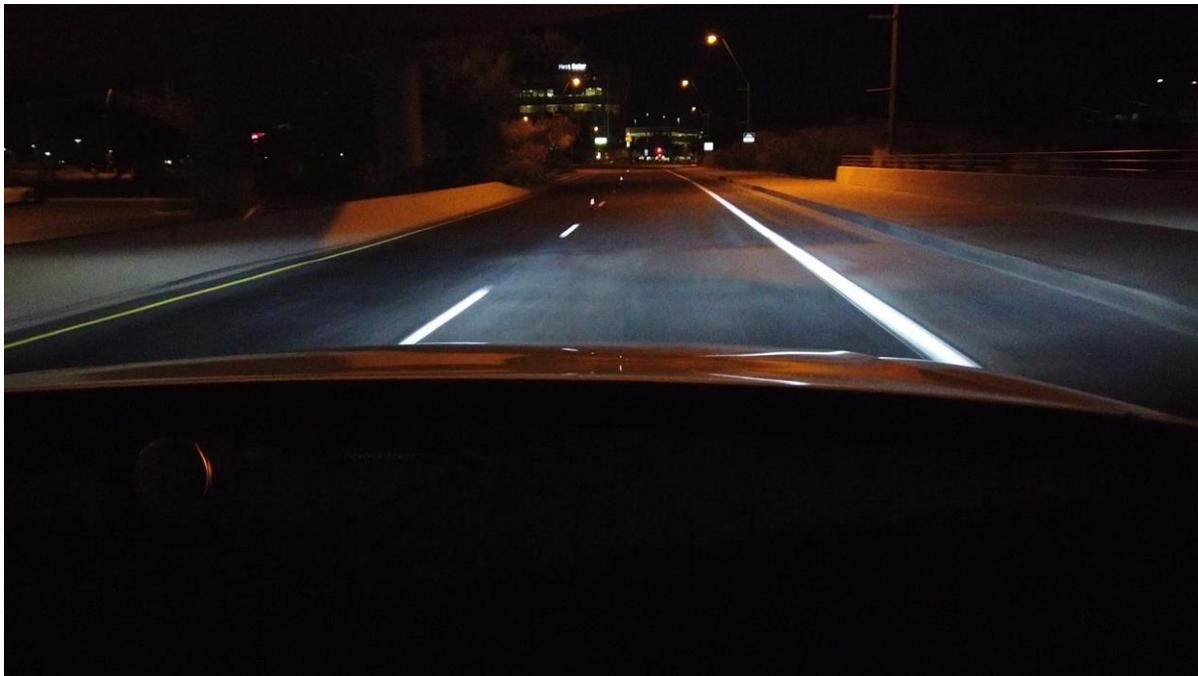
Figure 13 Osmo Pocket 400 feet from point of impact.

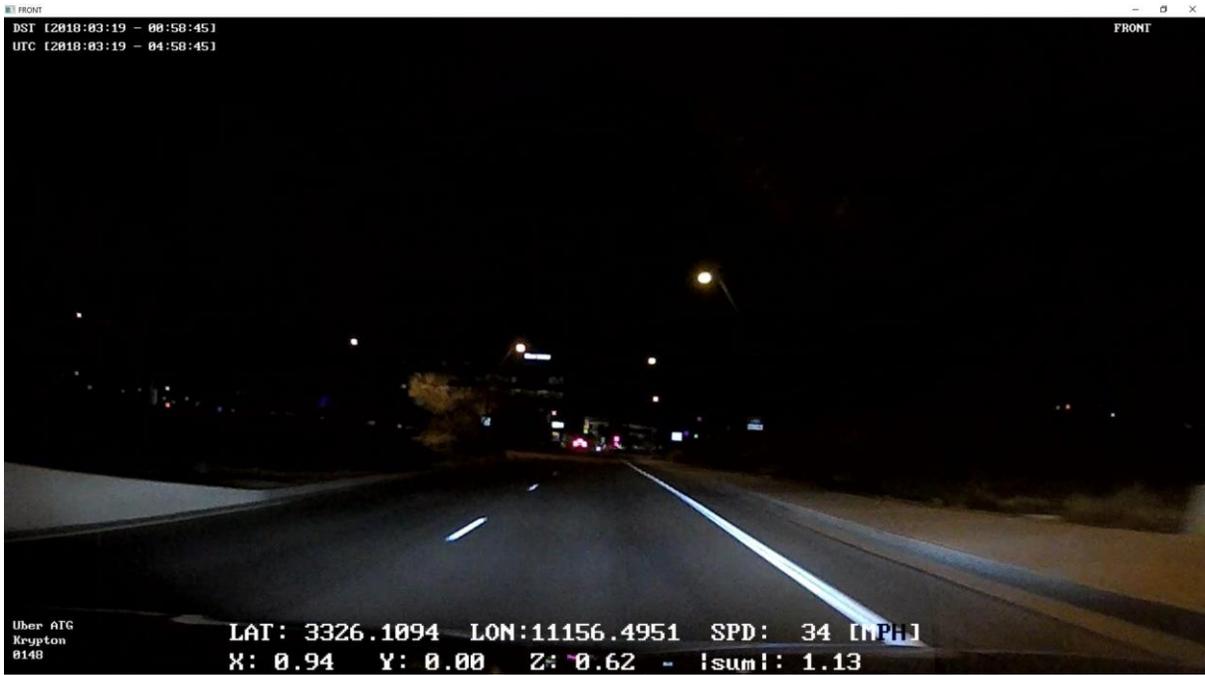
Figure 14 Accident video 300 feet from point of impact.

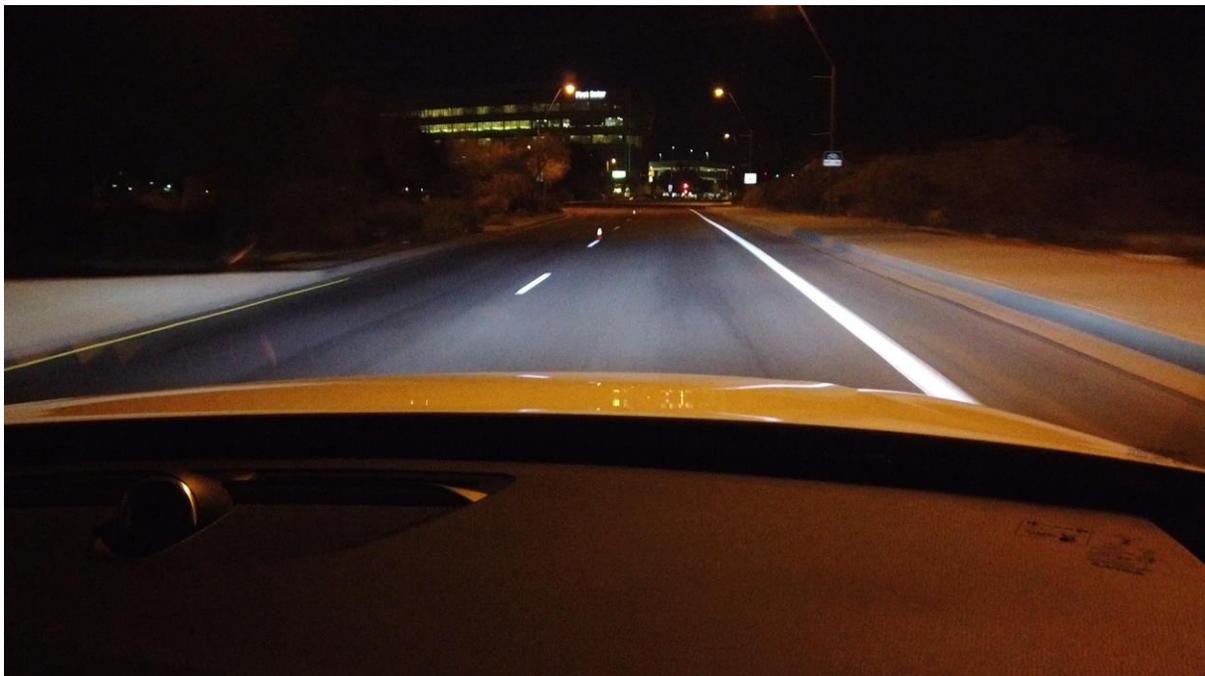
Figure 15 Osmo Pocket video 300 feet from point of impact.

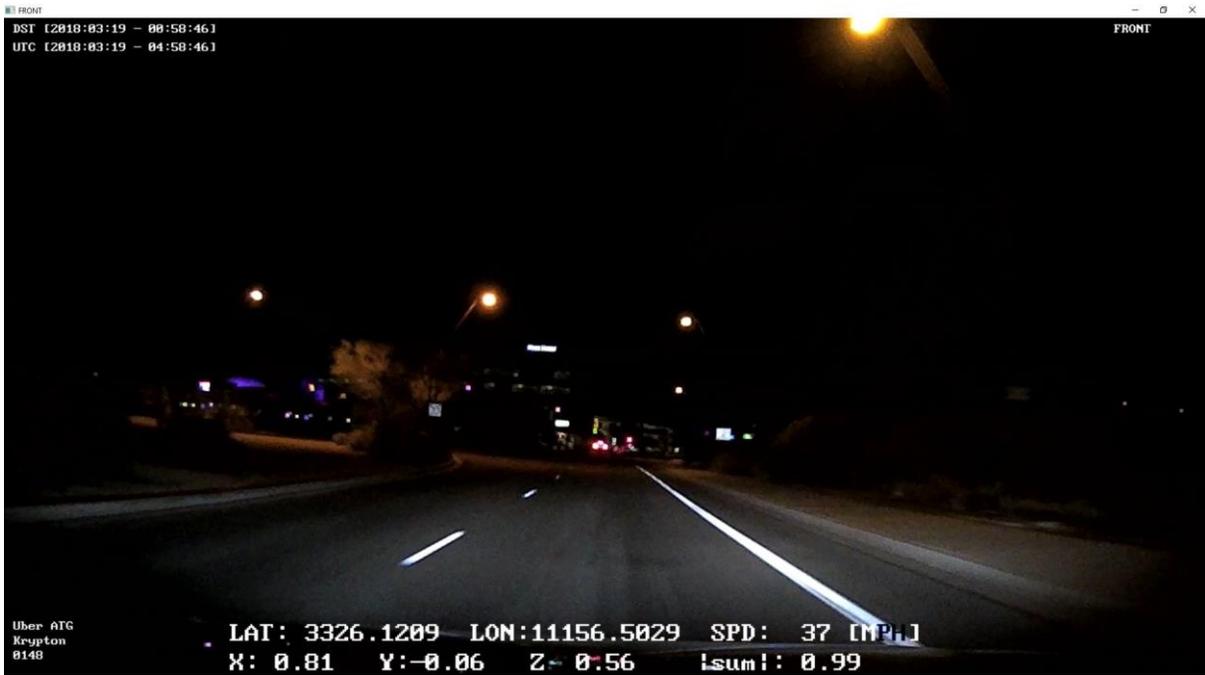
Figure 16 Accident video 200 feet from point of impact.

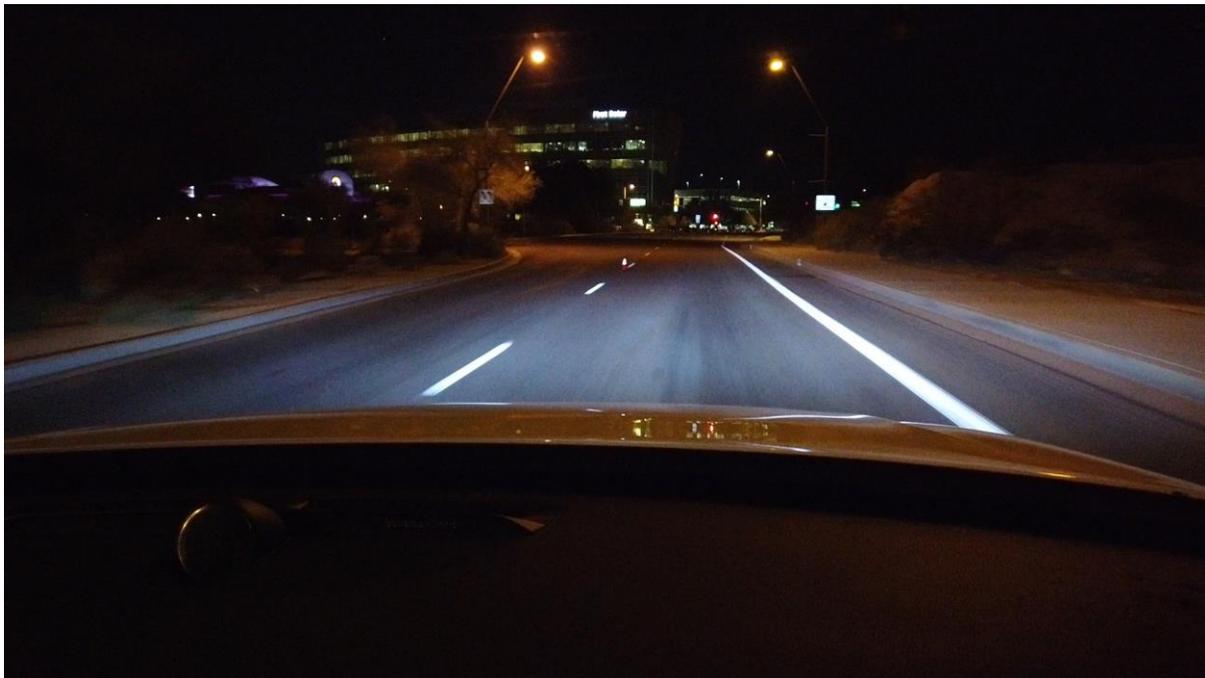
Figure 17 Osmo Pocket video 200 feet from point of impact.

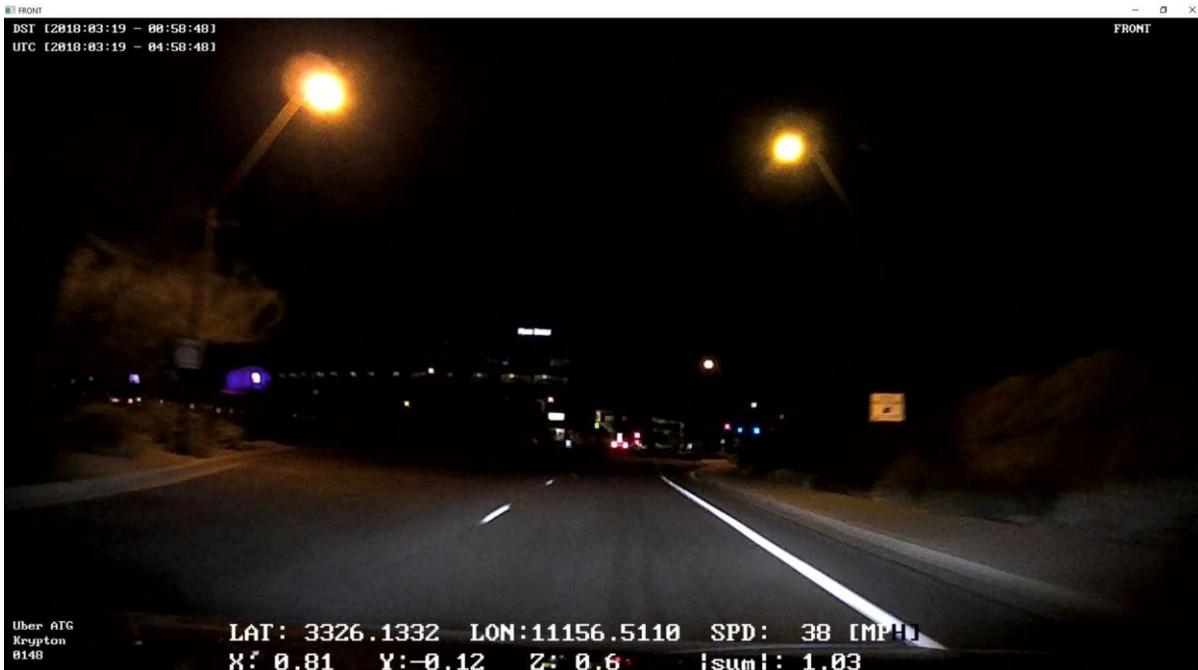
Figure 18 Accident video 100 feet from point of impact.

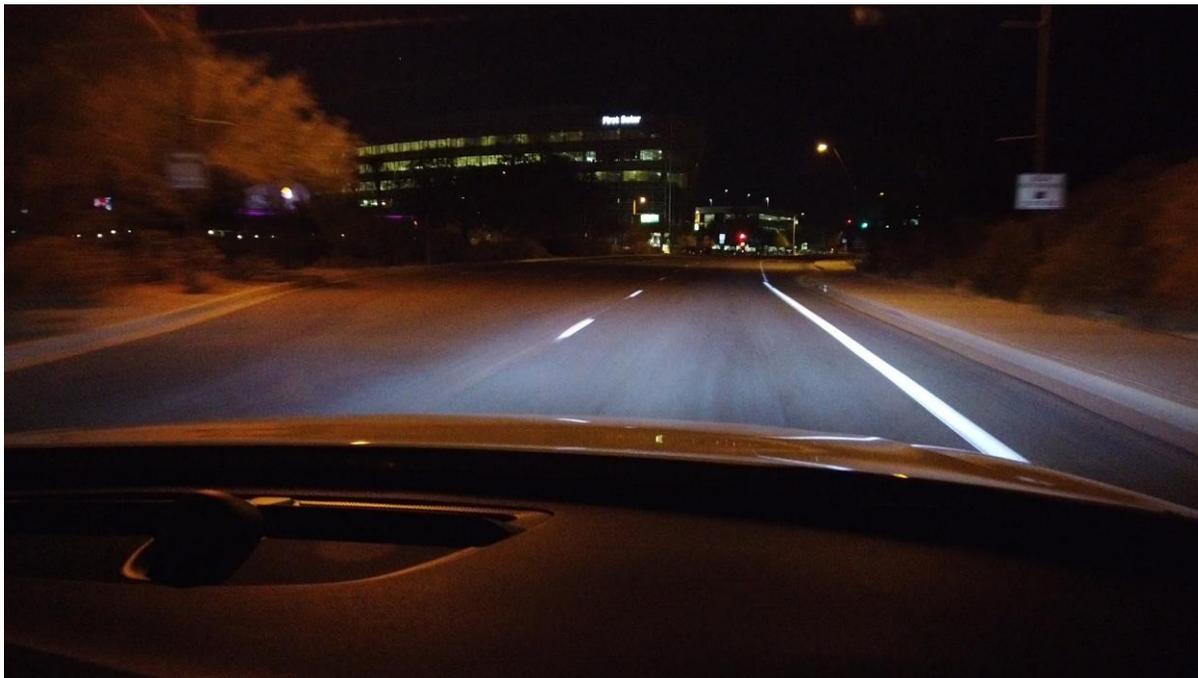
Figure 19 Osmo Pocket video 100 feet from point of impact.

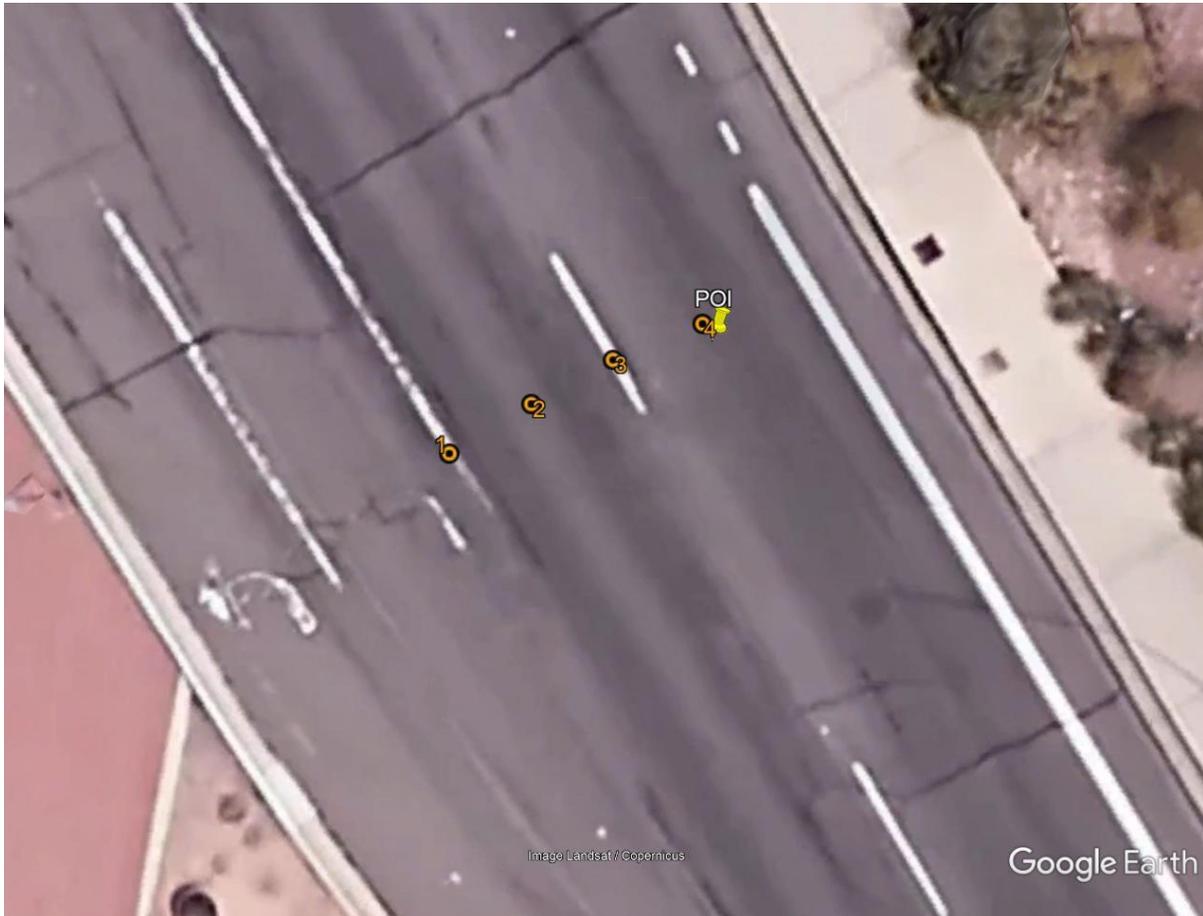
During the evening session, we made illuminance measurements along the track that Ms. Herzberg walked as she crossed North Mill Avenue. We made those measurements with the exemplar automobile on low beam at distances of 500 feet, 400 feet, 300 feet, 200 feet, 100 feet and at the point of impact from where Ms. Herzberg was struck. Measurements were made at each of four locations as shown in Figure 20.

Figure 20 The locations where illuminance measurements were taken.
